## Firmware Update Procedure

For NXR-5700/5800/5900/5901

August-20/2018

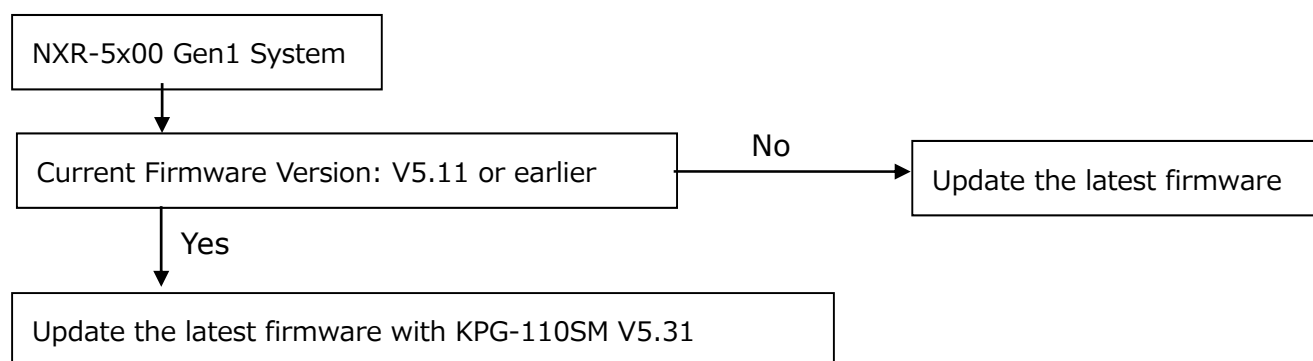
### 1. Firmware Update flow for the Gen1 Trunking System

If NXR-5x00 series repeaters are built as the Gen1 Trunking System, the Firmware Update Tool is not required. Please update the firmware to refer the following flowchart.

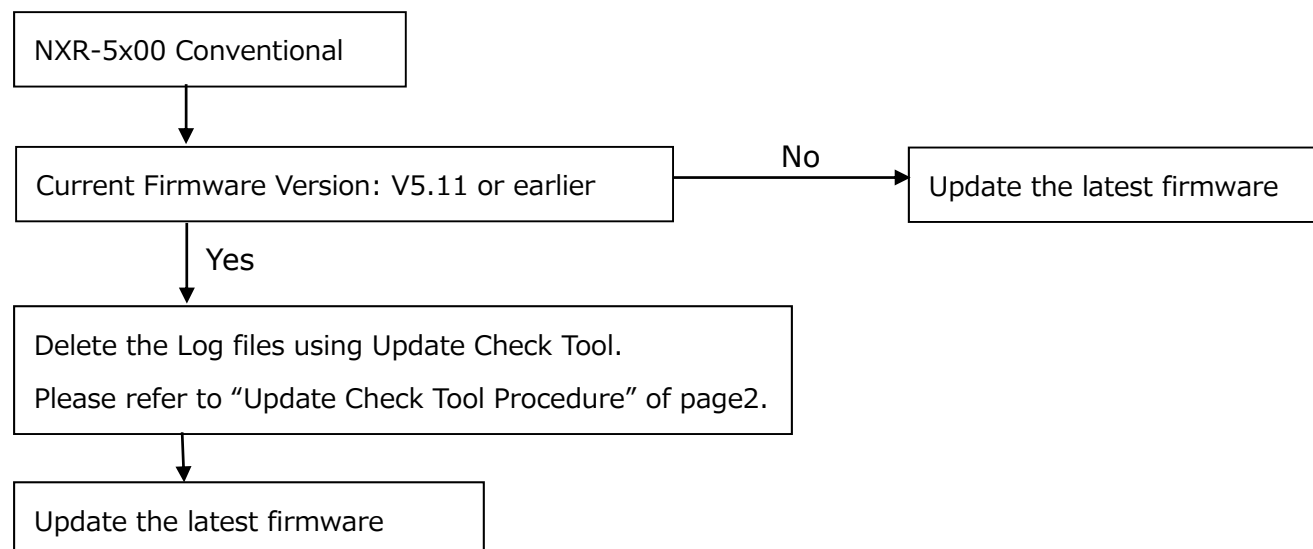
### 2. Firmware Update flow for the Conventional System

Please update the firmware to refer the following flowchart.
